On the Excessive Porosity in the Welds of AMS 4975 Titanium Air Compressor Rotor Duct

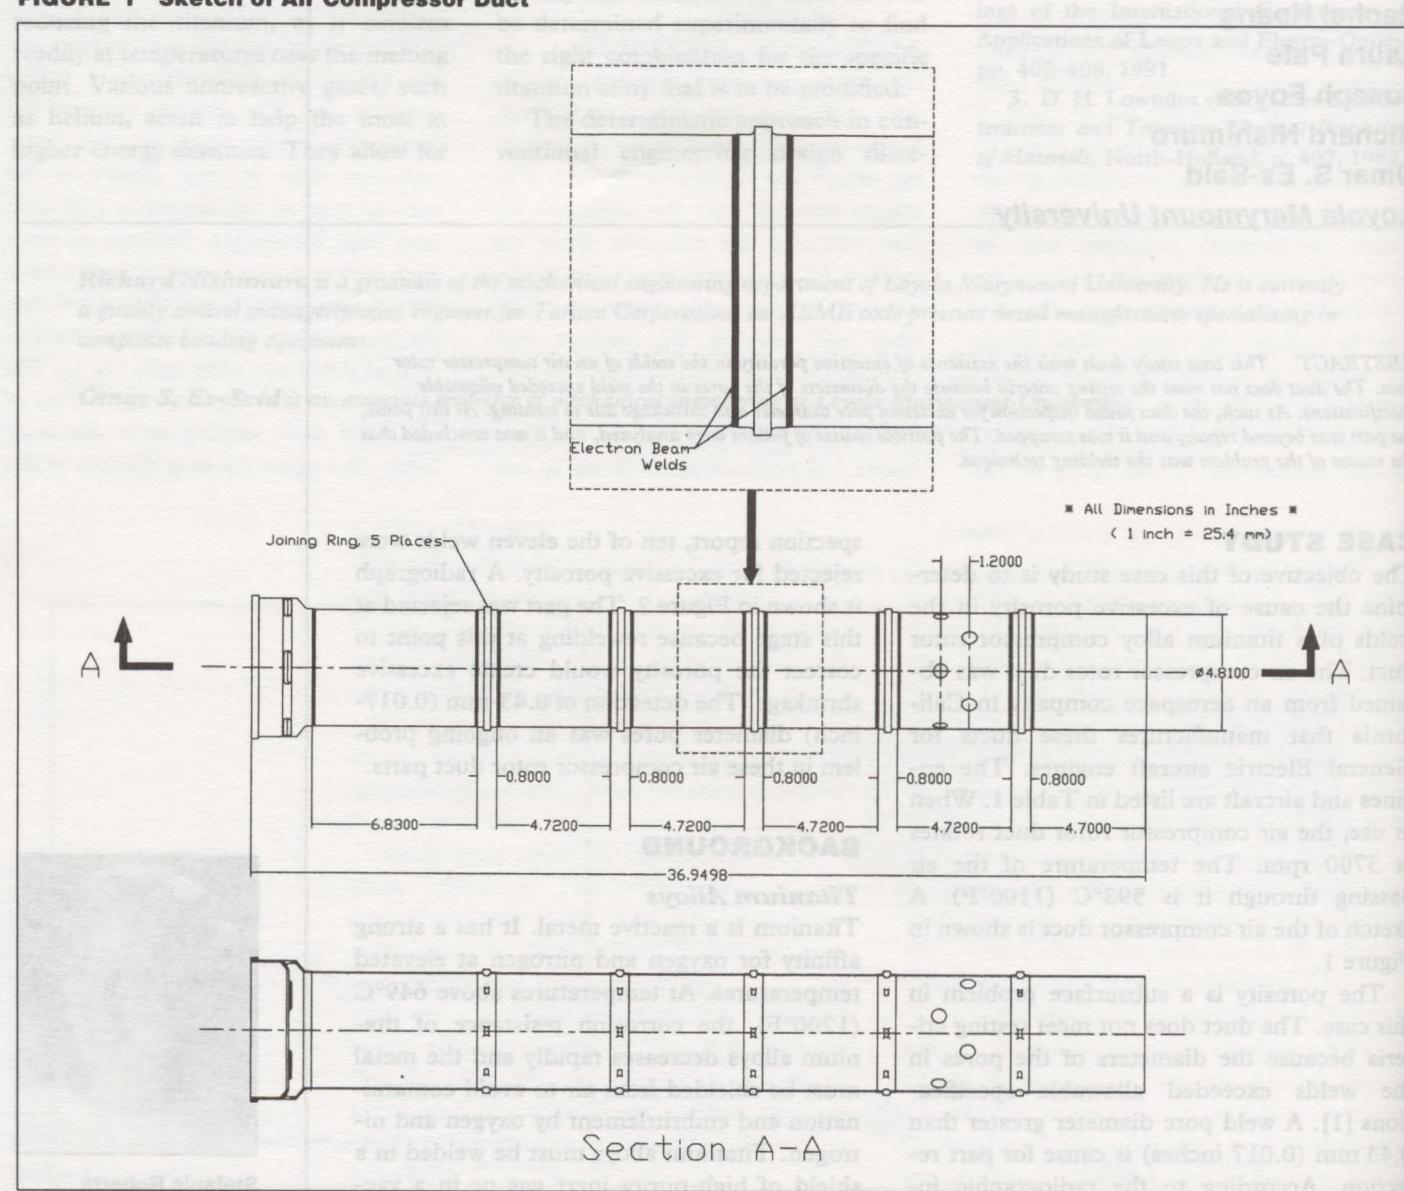
FIGURE 1 Sketch of Air Compressor Duct

The objective of this case study is to determine the cause of excessive porosity in the welds of a titanium alloy compressor rotor duct. The air compressor rotor duct was obtained from an aerospace company in California that manufactures these ducts for General Electric aircraft engines. The engines and aircraft are listed in Table 1. When in use, the air compressor rotor duct rotates at 3700 rpm. The temperature of the air passing through it is 593°C (1100°F). A sketch of the air compressor duct is shown in Figure 1.

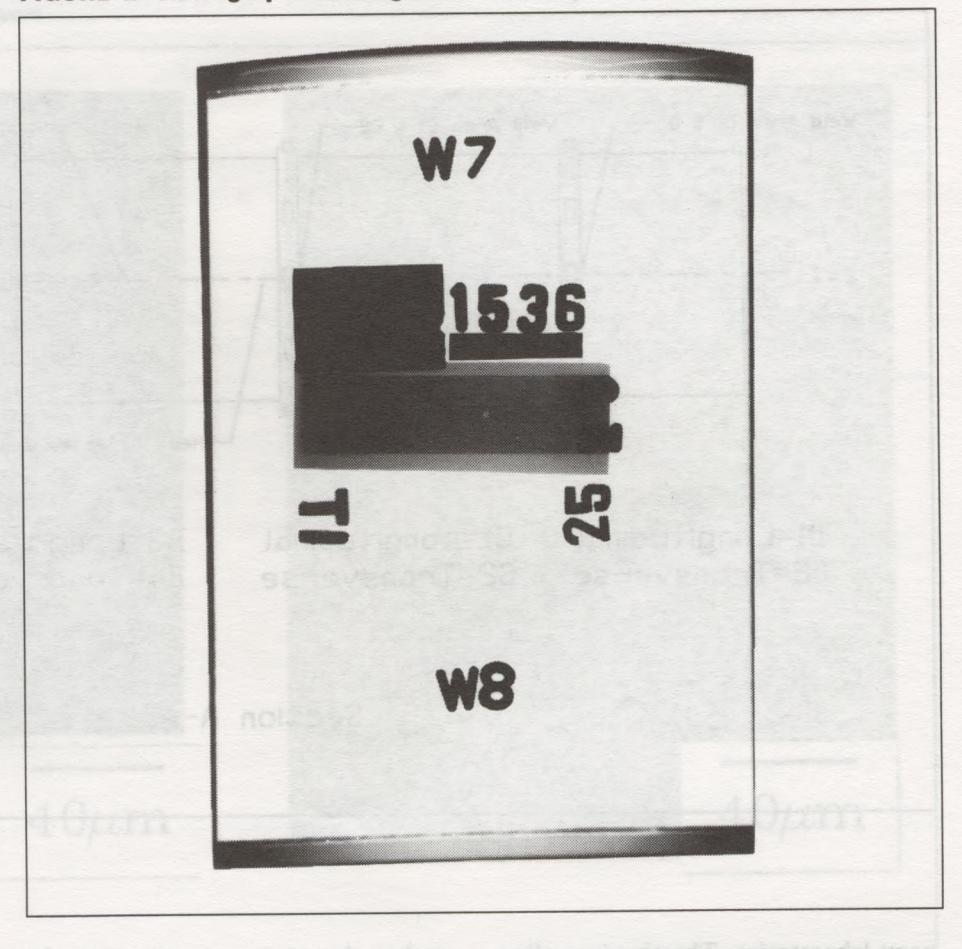
The porosity is a subsurface problem in this case. The duct does not meet testing criteria because the diameters of the pores in the welds exceeded allowable specifications [1]. A weld pore diameter greater than 0.43 mm (0.017 inches) is cause for part rejection. According to the radiographic inspection report, ten of the eleven welds were rejected for excessive porosity. A radiograph is shown in Figure 2. The part was rejected at this stage because rewelding at this point to correct the porosity would create excessive shrinkage. The detection of 0.43-mm (0.017inch) diameter pores was an ongoing problem in these air compressor rotor duct parts.

The possibility of hydrogen in solution in the metal was eliminated by tests conducted at the aerospace comFIGURE 2 Radiograph Showing the Presence of Pores

The aerospace company should employ the high-voltage/high-weld speed techniques in the EBW process for the titanium air compressor rotor ducts. The beam voltage should be increased from 80 kV to around 150 kV, and the weld speed should be increased from 12 to 120 ipm. A high-vacuum system $(10^{-3}-10^{-6} \text{ TORR})$ should be maintained to reduce the likelihood of contamination by atmospheric gases.

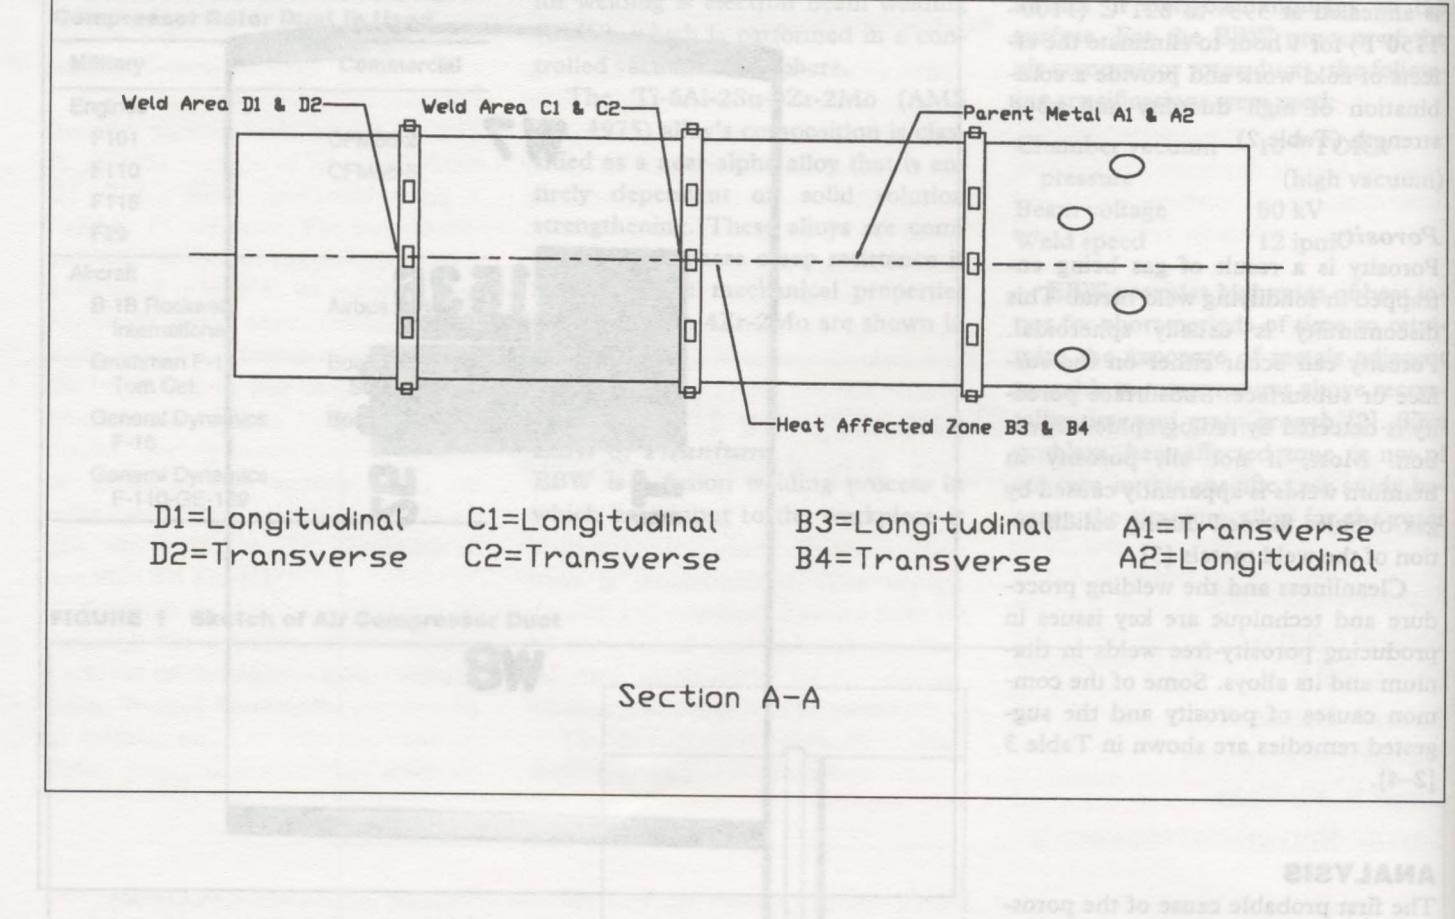
FIGURE 3 Location of the Optical Microstructures

Figure 3 shows the rotor duct. Four areas have been identified: A1/A2 parent unaffected metal; B3/B4 heat affected zone; C1/C2 fusion zones; and D1/D2 fusion zones. The designations 1 and 2 refer to longitudinal and transverse views. In Figure 4, the microstructures of the parent unaffected metal (A1) and the heat-affected zone (B1), top right and left, indicate equiaxed fine grains, whereas those of the fusion zones (C1 and D1), bottom right and left, reveal elongated coarse grains.

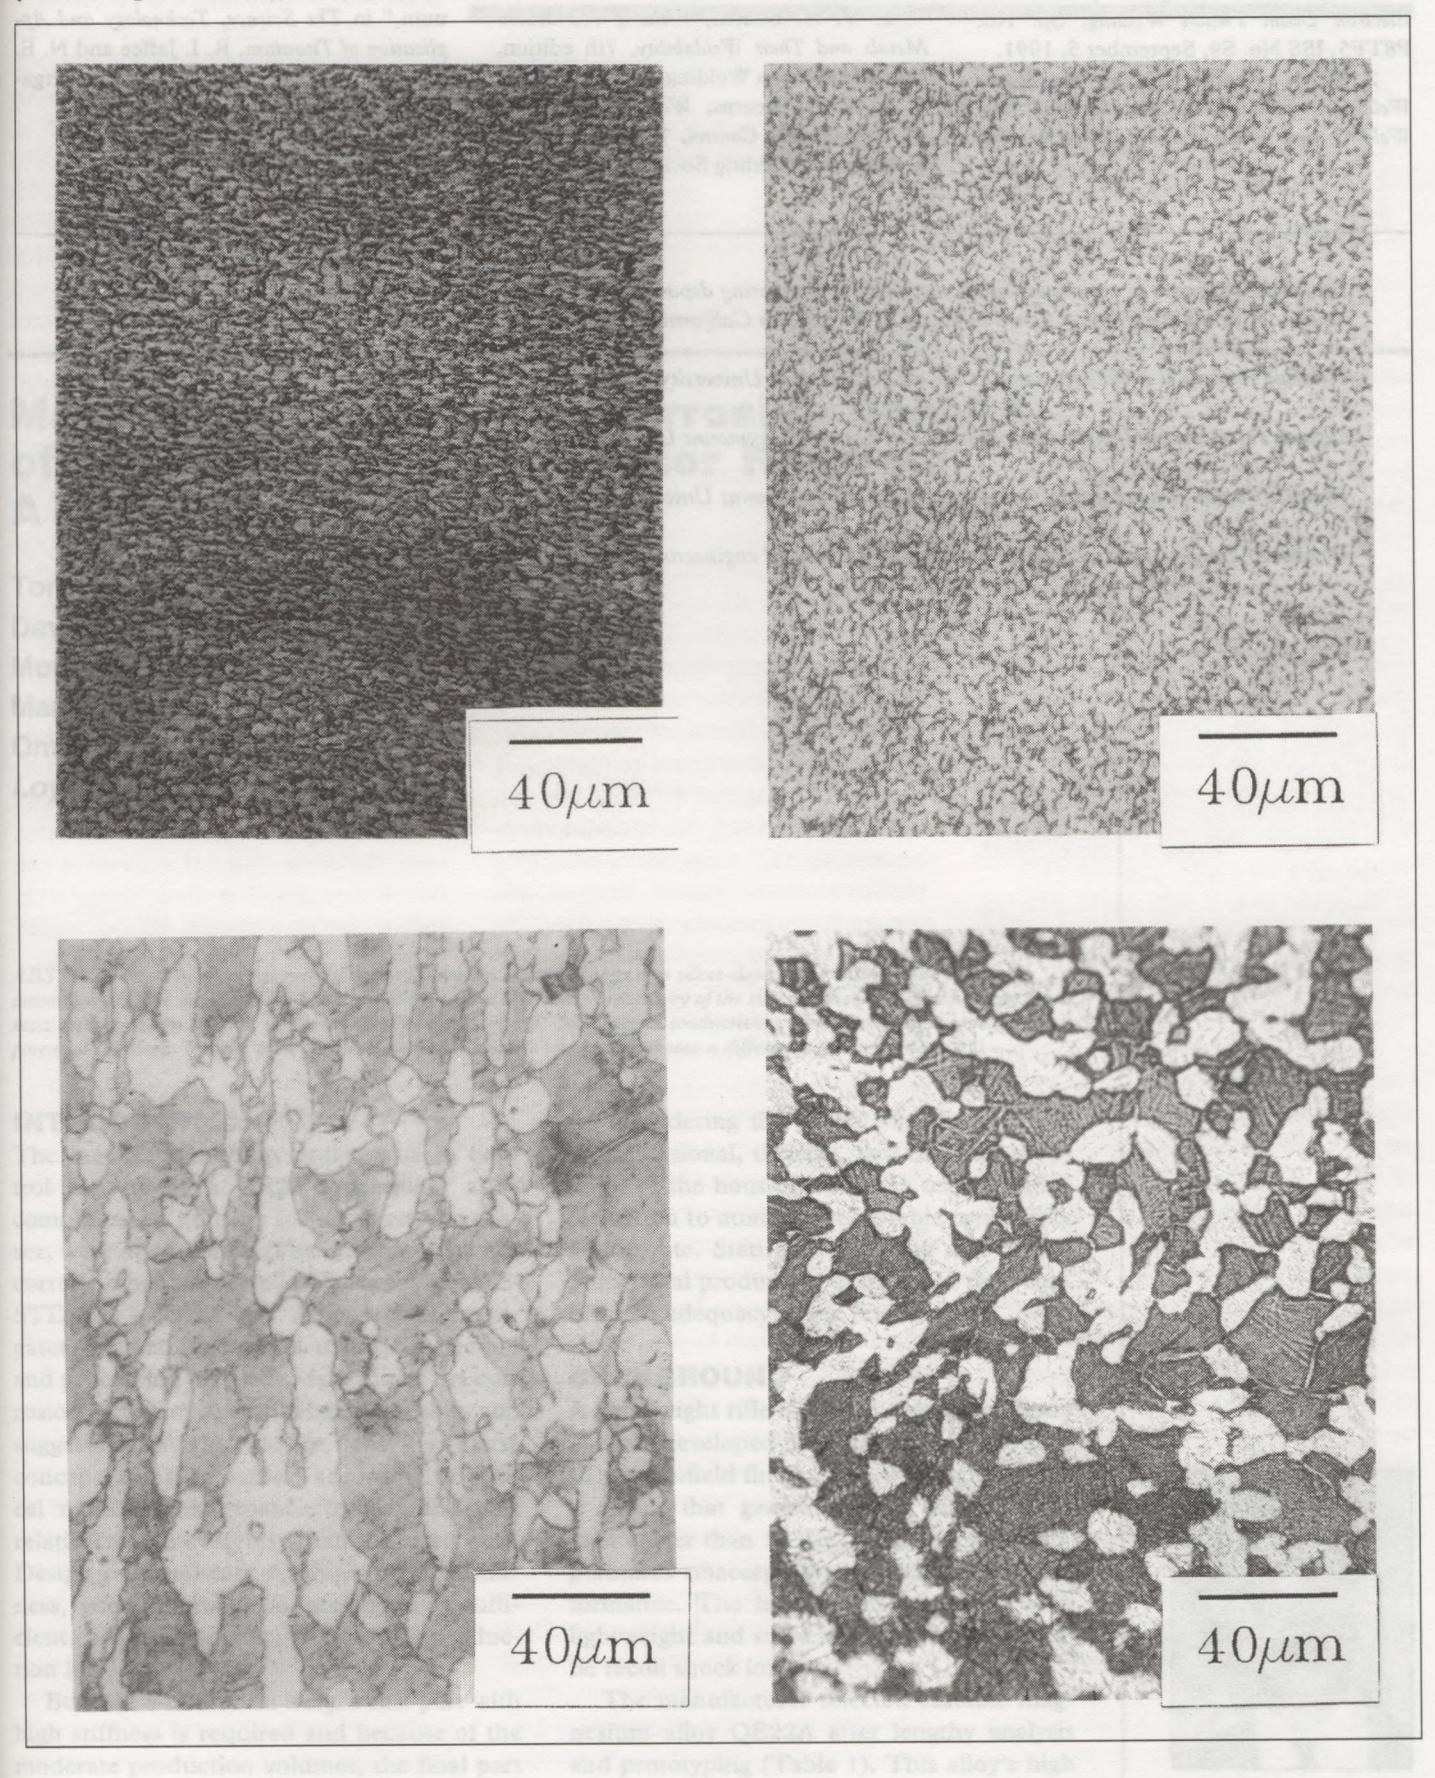
Special thanks to Dean T. Calder, Mrs. S. B. Es-Said, and Mrs. Olga Rivera for their help in preparing the manuscript. FIGURE 4 Optical Microstructures of the Parent Metal (top left), Heat-Affected Zone (top right), and Fusion Zones (bottom right and left), Longitudinal Views
