On the Effectiveness of Dry Film Lubricant Coatings in Reducing Automotive Valve Train Wear

ABSTRACT. *The effect of three dry lubricants on automotive valve train wear resistance was studied experimentally. Scuffing wear occurs as the cam slides across the lifter face where the rotating motion of the camshaft is converted into the linear motion necessary to drive the cylinder head valves. This scuffing is caused by localized microscopic bonding between the skidding surfaces. It can be minimized by using dry film lubricant coatings to increase the boundary lubrication depth adjacent to the contact area. To compare valve train wear resistance in the laboratory, rotating cam lobes coated with dry lubricants—parkerization, spray-applied graphite coating, and brush-applied molybdenum disulfide coating—were pressed against valve lifters that were constrained in a fixture. The brush-applied molybdenum disulfide coating was the most effective of the three tested lubricants in reducing scuffing wear.*

This article provides an overview of the scuffing wear mechanism and a laboratory evaluation of the three coatings in a test fixture designed to simulate cam/lifter conditions during engine

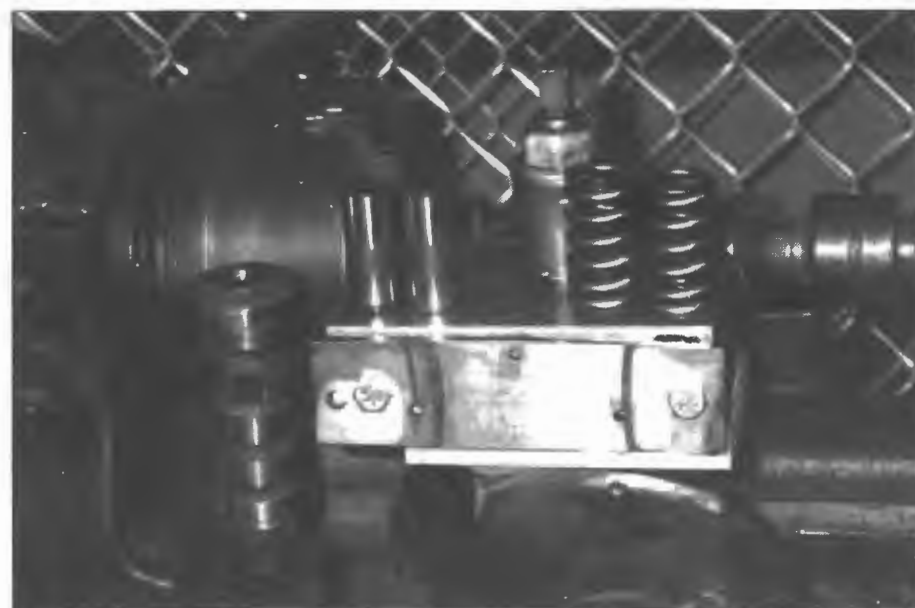
Engine conditions were simulated [9] by rotating each camshaft in a lathe at 500 rpm. In order to prevent deflection in the camshafts, each was cut at its bearing points prior to mounting. Individual cam lobes were placed in contact with a follower and loaded to 270 lbf at 0° cam rotation by use of a valve spring. At the beginning of each test, engine oil was applied to each cam lobe assist break-in at the interface. Each camshaft was then rotated for 12 h under load before removal from the test apparatus for measurement of surface wear. The conditions and duration of the test were chosen to

simulate the harsh break-in period that exists in most four-stroke engines. The rotational speed chosen is representative of the camspeed of an engine running at 1000 rpm, or at a speed appreciably above idle. The time duration was arbitrarily chosen. The test apparatus is shown in Figure 3.

FIGURE 3 Test Apparatus: Test Equipment Mounted in Lathe (Front View)

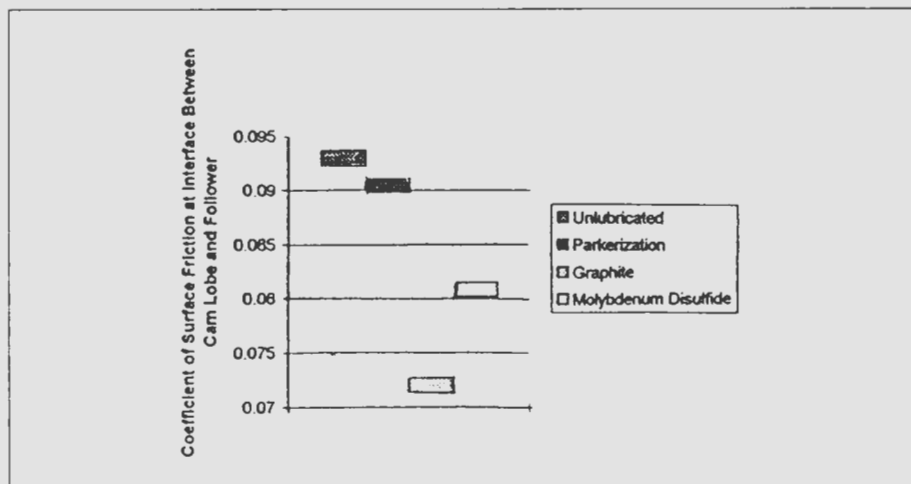
Lubricant Type	Coefficient of Static Friction at Interface between Cam Lobe and Follower
Unlubricated	0.0920–0.0937
Parkerization	0.0899–0.0911
Graphite	0.0704–0.0727
Molybdenum Disulfide	0.0802–0.0815

FIGURE 4 Histogram of Coefficients of Static Friction for Each Camshaft-to-Lifter Interface, by Lubricant Type

Coefficients of static friction at the camshaft-to-follower interface, correlating to each of the various dry film lubricant coatings, are displayed in Table 1 and Figure 4. Figures 5a-5c

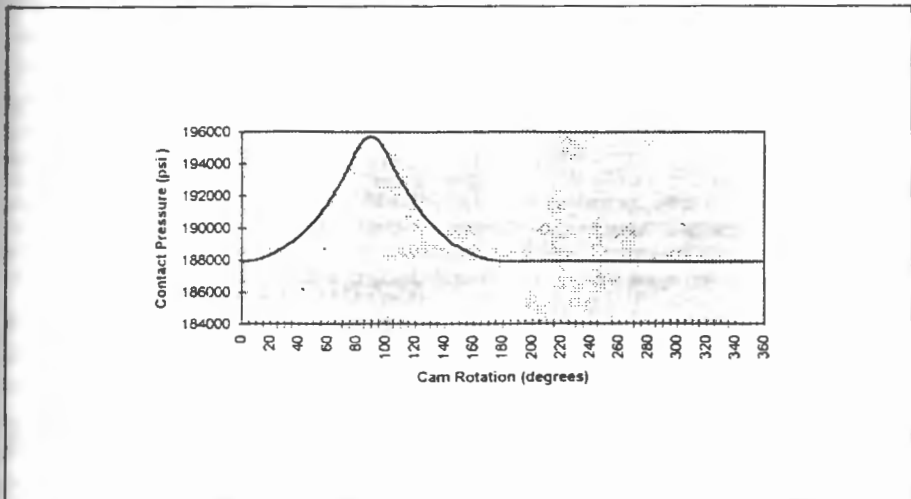
FIGURE 5a Cam-to-Follower Pressure Diagram

Significant wear of all followers also occurred at the interface point corresponding to maximum Hertzian contact stress and maximum follower slip ratio. As displayed in Figure 5a, the site of maximum Hertzian contact stress occurred at a cam angle of 90° , or at the point of maximum follower

lift. As shown in Figure 5c, the follower slip ratio simultaneously became infinite at this point (i.e., complete slipping occurred). This point corresponds to the center of each follower face. The experiment confirmed the detrimental effects of these combined conditions on the acceleration of scuffing wear. Again, the parkerization and molybdenum disulfide lubricants were successful in inhibiting accelerated scuffing wear at this site.

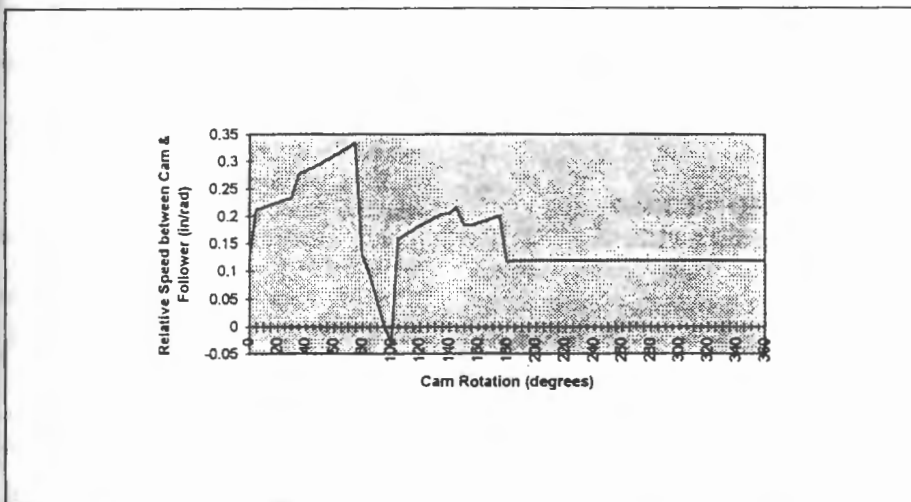
FIGURE 5b Relative Speed versus Cam Rotation

In the case of all followers, the site of maximum wear depth was found to correspond to the interface point where the magnitude of V^* (the relative velocity between the cam and follower) was at a minimum. As shown in

Figure 5b, this condition existed at a cam angle of approximately 100° , and again at a cam angle of approximately 105° . On the face of each follower, this site was offset from the center. It is believed that the thickness of the layer of engine oil lubricant here reached zero, and dry sliding contact occurred. The experiment confirmed that the conditions at this point are the most detrimental to the acceleration of scuffing wear in the system. However, it was found that the parkerization and molybdenum disulfide coatings proved successful in significantly reducing the wear rate at this site.
