Cities and the Environment

It Takes a Stewardship Village: Effect of Volunteer Tree Stewardship on Urban Street Tree Mortality Rates

Steven Boyce

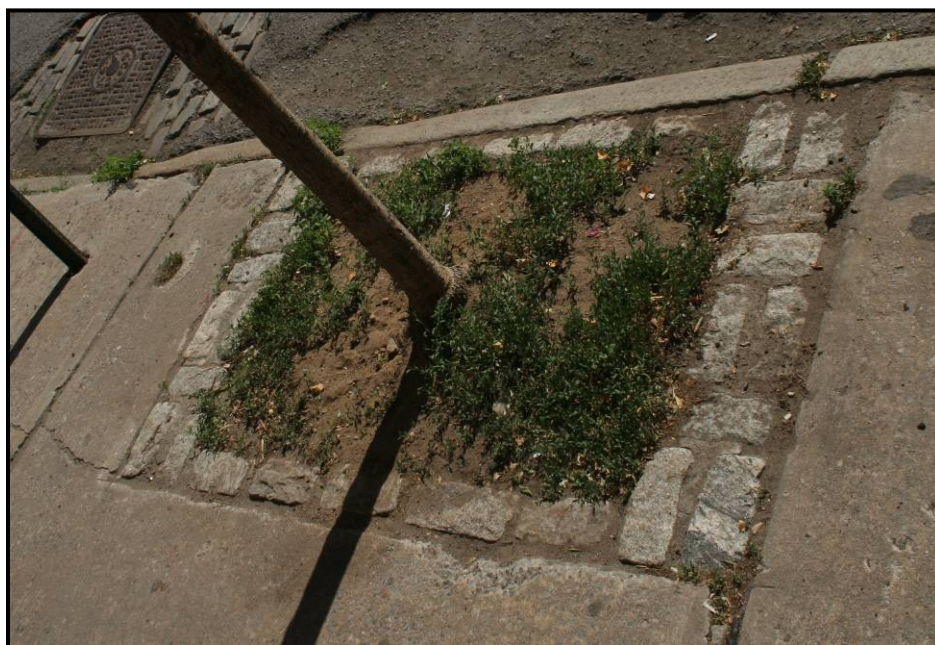
Figure 1. Typical Street Tree pit– 1.1m x 1.5m (3.5ft x 5ft).

dimension of about 1.1m by 1.5m. (see Figure 1); less than 10% of the tree pits are of the larger sizes encouraged under new city policies in place since 2007 (New York City Department of Parks and Recreation 2010).
